NEWS :

Focus on condition assessment of rotating machines

ROOT CAUSE ANALYSIS OF CRACKS IN TURBINE ROTOR COMPONENTS

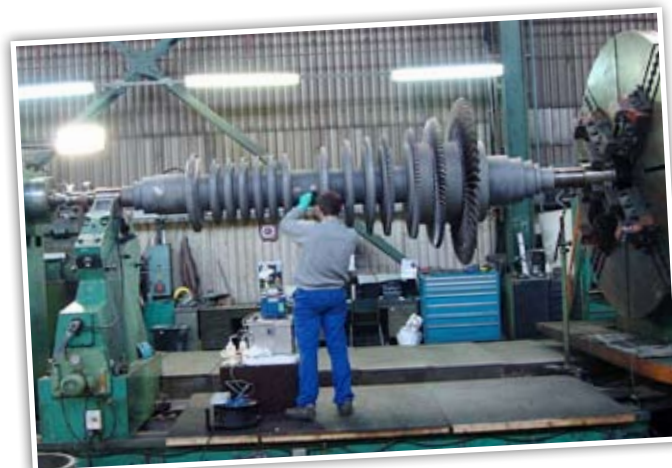
Steam turbine rotor during an inspection of one of the cracks.

'Small shaft surface cracks are normally machined off in order to avoid further crack propagation. In this case, the size of the crack was such that it could not be machined off,' explains Billet. 'We therefore recommended the use of a more sensitive vibration monitoring system to detect any critical crack propagation well in advance. Vibration sensor signals are now introduced into a Laborelec Vibration Monitoring System (LVMS). This means that continuous monitoring can be carried out remotely from Laborelec and that specific vibration pattern evolutions can be identified more quickly and easily.'

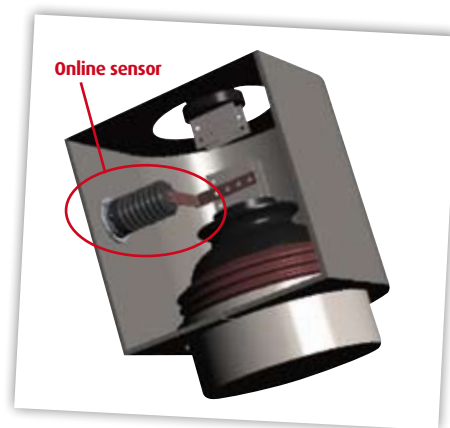
Laborelec simulates the specifics of the turbo-generator to determine the best location for online sensors.

In order to minimize maintenance downtime, Laborelec has complemented its service offering with online measurements. The installation of the online measurement tool starts with finding the best location for the sensors and connection boxes. 'We take pictures and establish the precise dimensions of the inside of the generator's terminal box. Computer simulations then identify the best location for the sensors. Once the plant validates our design, we carry out the installation,' states Van Cotthem. 'When everything is in place, we are able to conduct measurements at various loads and temperatures.'

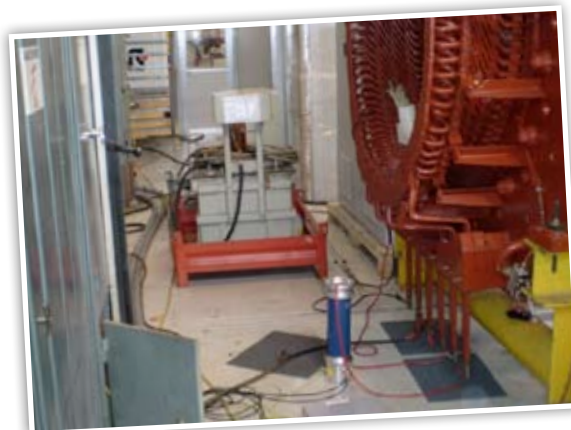
Our experts carried out partial discharge tests to identify the precise type of insulation wear.

Laborelec carried out partial discharge measurements on the plant's two generators. 'These measurements revealed the presence of discharges at the interface between the primary insulation and the conductors,' says Jean-Michel Meunier. 'This is dangerous for this type of multiple turn winding. In air cooled machines, in particular, partial discharges at the interface between the primary insulation and the conductors generate nitric acid, which attacks the conductor insulations. This in turn can cause short circuits between conductors. In this case, the winding and its primary insulation heat up locally. As a result, the dielectric properties of the primary insulation are altered, which can eventually result in a dielectric breakdown of the generator bar.'

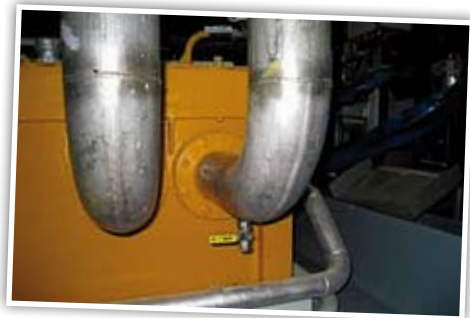
Good oil analysis requires proper oil sampling. Locations where the oil is very turbulent such as in a return pipe are excellent for collecting samples.

Oil sampling is also a major concern. Good oil analysis requires proper oil sampling. Therefore, our experts assist in finding the best sampling points. 'We suggest locations where the oil is very turbulent, preferably in a return pipe. This allows us to collect samples with the most representative levels of wear debris and contaminants,' notes Laborelec oil expert Koen Balman. 'We take these rules into account when we work out a new oil sampling procedure for our clients.'

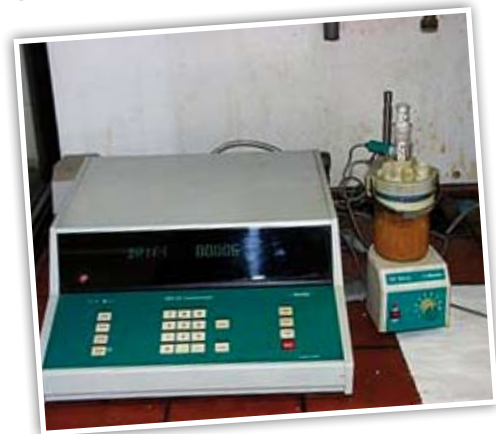
Laborelec's state-of-the-art oil laboratory enables the rapid identification of possible lubrication oil contaminants.
