[NEWS : focus on materials technologies, condition assessment, and non-destructive testing

ROOT CAUSE ANALYSIS AT ROSEN POWER PLANT, ITALY

GROWING INTERNATIONAL ACTIVITIES FOR POWER PLANTS

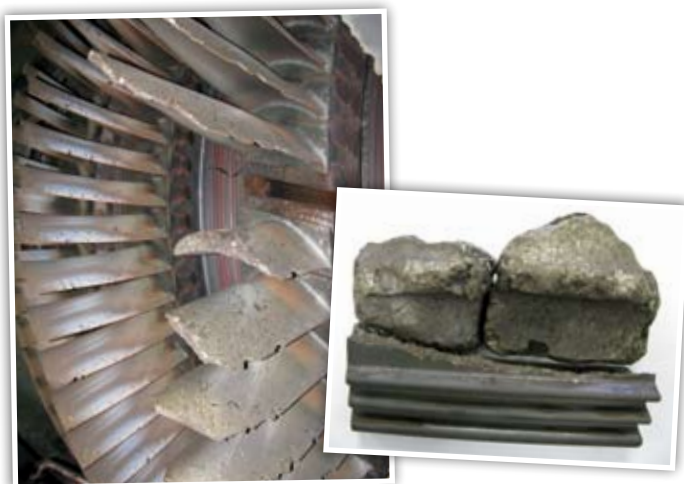
A broken rotor blade caused significant damage inside the gas turbine at the Rosen power plant. The insurance company reimbursed the repair costs based on the investigative results of Milan University and Laborelec.

Laborelec's Xavier Degive followed the university's investigation as a technical consultant for the Rosen power plant. 'Visual inspection immediately showed signs of fatigue. The subsequent fractography revealed fretting damage at the fracture location. Upon further examination of the broken blade, the university found a small soft layer around the fir-tree at the root of the blade that enabled the fretting damage to occur.'

Laborelec, however, was wondering why there was a soft area to begin with. Our experts decided to analyse matters in greater detail and came to an astonishing conclusion. 'The roots of the rotor blades were not shot peened during their refurbishment,' states Sigrid Gijbels. 'Shot peening is a critical step after heat treatment in order to mitigate the risk of crack initiation. The sector considers this a best practice. We advised the OEM to make it an essential part of his refurbishment procedures.' The insurance company was convinced by the combined investigative results and decided to cover the costs caused by the breakdown.

- One of the rotor blades at the Rosen power plant in Italy failed and caused significant secondary damage in the gas turbine
- Milan University's Materials Department revealed fretting fatigue in the crack, which initiated in a soft area around the blade's fir-tree
- Laborelec's investigation revealed that the blades had not been shot peened after refurbishment, although it is an essential process to mitigate the risk of crack initiation

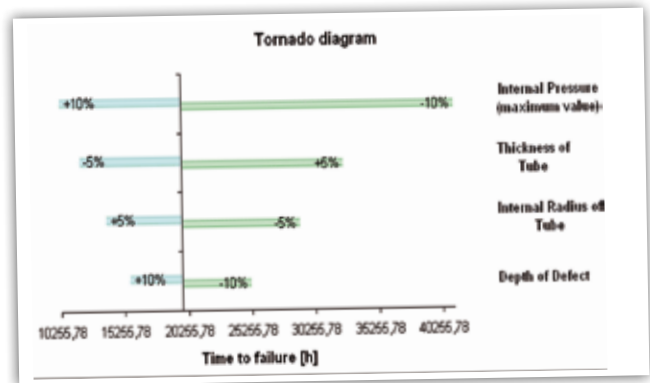
The software includes a sensitivity analysis which immediately compares the remaining time sensitivity with the input accuracy.

Crackfit is based on a specified set of physical parameters in order to provide a rapid diagnosis. These include type of geometry, stress, operating pressure and temperature, as well as depth, length, and position of the crack. Other operating parameters, such as the number of starts and stops, are also taken into account. 'The software is designed to assess a large number of different geometries, including pipes, tubes, T-shapes and nozzles. It can be used for a wide range of dimensions, thicknesses, and types of structural faults,' adds Grégoire. 'Laborelec has validated the implementation of the software's mathematical formulas and geometries.'

Based on the given parameters, the software calculates how the crack will evolve. It graphically represents at what point in time the tube is virtually certain to break. The programme features a red, orange, or green light that immediately indicates the risk of continuing to use the tube as is. Laborelec has also tested the user-friendliness of the tool.

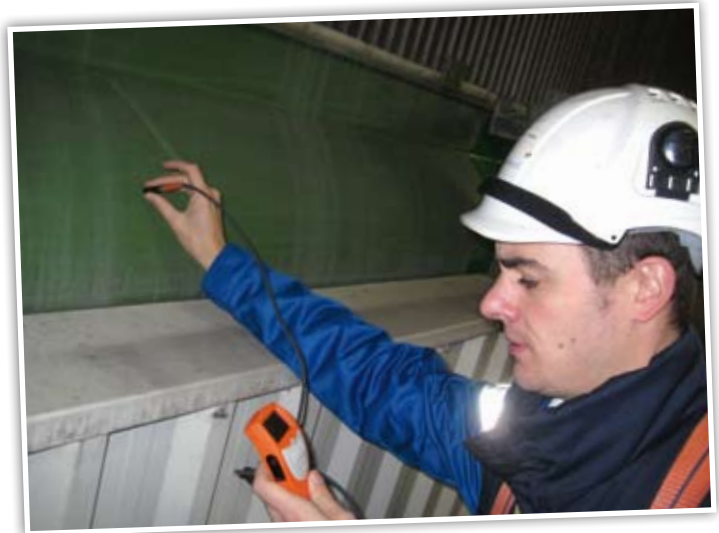
Measuring dry film thickness is one of the quality checks carried out by Laborelec.

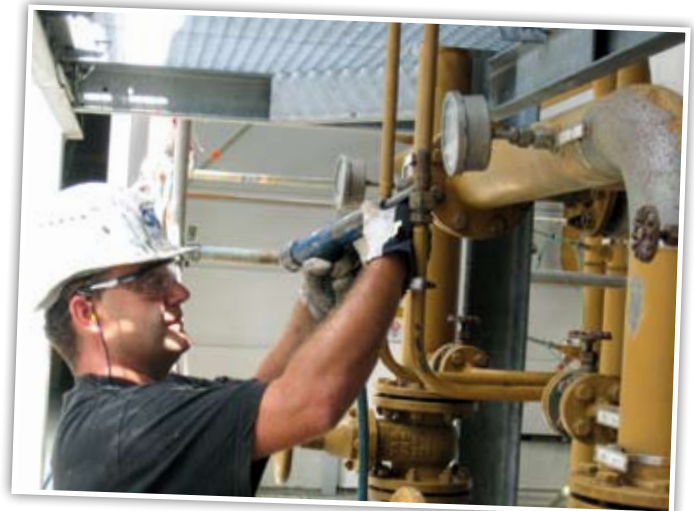
Removing rust during surface preparation is critical in ensuring a long paint lifetime.

‘The Herdersbrug power plant recently contacted us regarding new anti-corrosion paints in its air intake, condensate, and oil pipes,’ explains Maarten Vos. ‘We first verified that the rust and dirt on the pipe surfaces were eliminated according to the specifications. We then suggested applying a layer of aluminium primer, followed by an intermediate and top paint layer. Such a coating system guarantees very low permeability and excellent corrosion resistance. The painting works were carried out by external painters under our supervision. During and after these works, we undertook quality checks. We measured the temperature, relative humidity, and thickness of the paint layer using magnetic induction equipment. We also carried out visual inspections to detect any pores or areas with a lack of adhesion.’
